# **Intel® Mobile Pentium® III Processor Specification Update**

Release Date: February 2001

Order Number: 245306-016

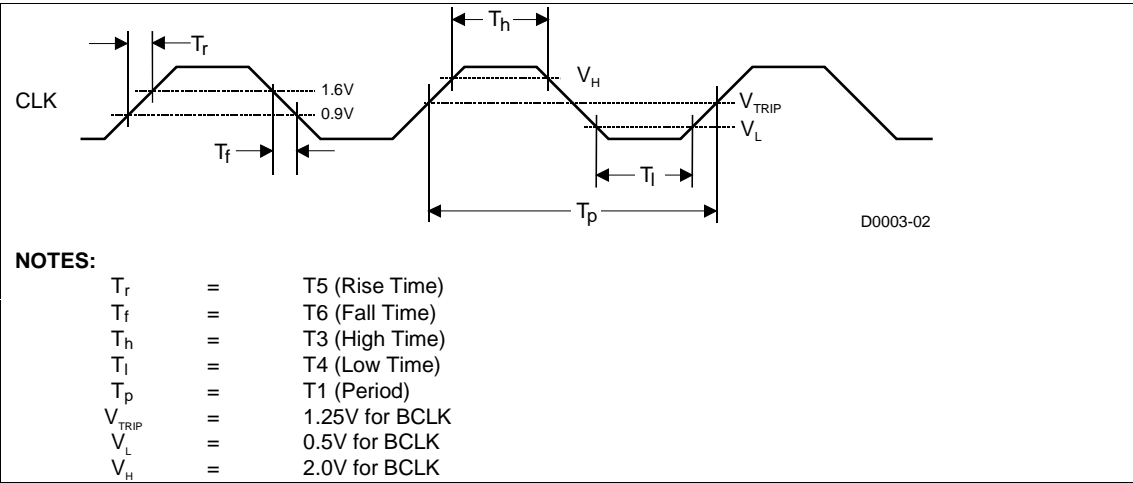
Figure 7. BCLK Timing Waveform

Symbol	Parameter	Min	Typ	Max	Unit	Figure	Notes
	System Bus Frequency		100		MHz		
T1	BCLK Period		10		ns	Figure 7	Note 2
T2	BCLK Period Stability			$\pm 250$	ps		Notes 3, 4
T3	BCLK High Time	2.70			ns	Figure 7	at >2.0V
T4	BCLK Low Time	2.45			ns	Figure 7	at <0.5V
T5	BCLK Rise Time	0.175		0.875	ns	Figure 7	(0.9V – 1.6V)
T6	BCLK Fall Time	0.175		0.875	ns	Figure 7	(1.6V – 0.9V)

1. All AC timings for GTL+ and CMOS signals are referenced to the BCLK rising edge at 1.25V. All CMOS signals are referenced at 0.75V.
2. The BCLK period allows a +0.5 ns tolerance for clock driver variation.
3. Not 100% tested. Specified by design/characterization.
4. Measured on the rising edge of adjacent BCLKs at 1.25V. The jitter present must be accounted for as a component of BCLK skew between devices.

For B0 step processors, the  $V_{IH,BCLK}$  Min spec is changed to 2.0V (from 1.7V for A2 step) and  $V_{IL,BCLK}$  Max spec is changed to 0.5V (from 0.7V for A2 step). Due to this, new values are specified for BCLK high and low times for B0 step processors. These modifications affect corresponding specs in Table 13, Table 14, Table 24, and Figure 7 in *Mobile Pentium® III Processor in BGA2 and Micro-PGA2 Packages datasheet* (Order Number 245302-002).
